PARTS BREAKDOWN

1109.14

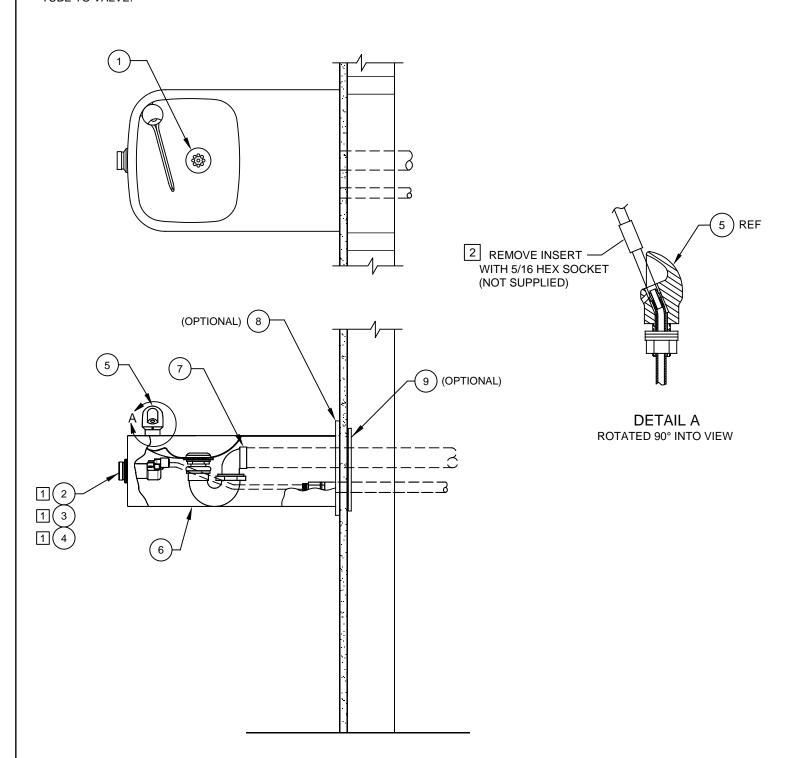
1 | 5874PBF (ITEM 2) INCLUDES VRK5874 CARTRIDGE ASSEMBLY (ITEM 3) AND PBA6 FLANGED PUSH BUTTON (ITEM 4).

2 ENSURE TUBE IS DISCONNECTED FROM PUSH BUTTON VALVE BODY PRIOR TO REMOVAL. APPLY ONE DROP OF LOCTITE 222MS TO NOZZLE THREADS PRIOR TO FASTENING BACK ONTO BUBBLER HEAD. RE-ATTACH TUBE TO VALVE.

ITEM	DESCRIPTION	1109.14
	1	STRAINER, WASTE ASSY	6462
	2	BUTTON, PUSH, FLANGED, PCP W/ VALVE	5874PBF
	3	VALVE REPAIR KIT	VRK5874
	4	PUSH BUTTON ASSY, FLANGED, PCP	PBA6
	5	BUBBLER HEAD ASSY, PCP	5703M
	6	PLATE, BOTTOM	PBM1109
	7	TRAP	0005982900
*	8	BACK PANEL	BP3
*	9	PLATE, MOUNTING	6700
