Are Your Fiberglass Posts *Fading & Blooming?*

Rhino 3-Rail™ *Fiberglass Composite Marker*

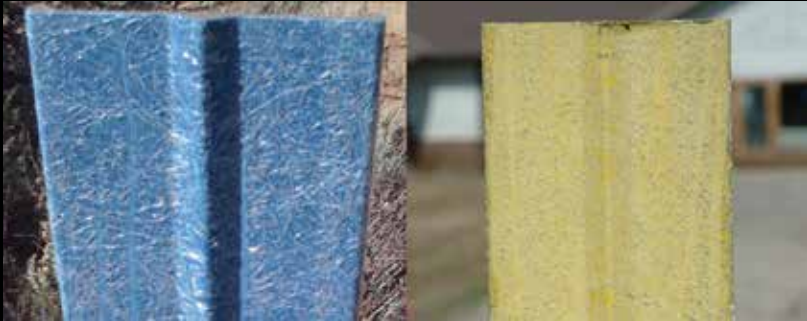
Traditional fiberglass posts get fuzzy over time when the damaging effects of UV light cause the surface resin of the post to evaporate. Without the surface resin, the glass fibers become exposed, not only causing significant fading, but posts in this condition can be a safety hazard to any person or animal that may come into contact with it.

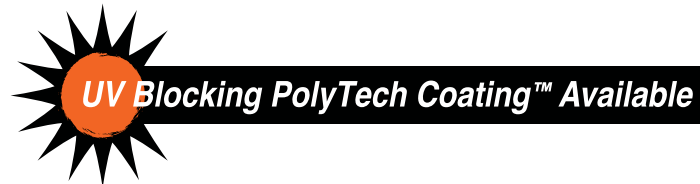
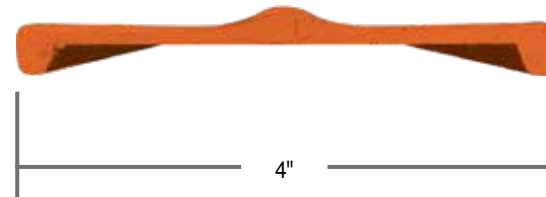
Rhino's 3-Rail fiberglass composite post uses the industry standard profile. It's our most drivable fiberglass marker and can be installed in almost any soil condition. The design allows for easy stacking, storing and has the durability to withstand repeated impacts when hit from the front or back.

- ▲ Pultruded fiberglass set in a composite resin
- ▲ Side-rails and reinforcing rib provide strength and rigidity
- ▲ Temperature stable
- ▲ Fire resistant
- ▲ Pointed end for easy installation
