Are Your Fiberglass Posts *Fading & Blooming?*

Rhino 3-Rail™ Fiberglass Composite Marker

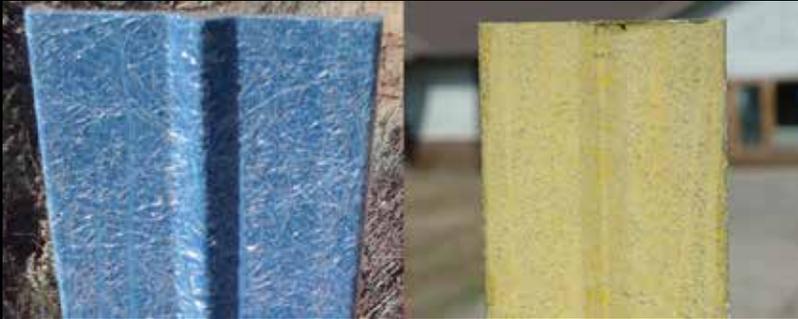
Traditional fiberglass posts get fuzzy over time when the damaging effects of UV light cause the surface resin of the post to evaporate. Without the surface resin, the glass fibers become exposed, not only causing significant fading, but posts in this condition can be a safety hazard to any person or animal that may come into contact with it.

Our patented PolyTech Coating™ blocks damaging UV rays, prevents fiberbloom, and is available on all of our Fiberglass Composite posts.

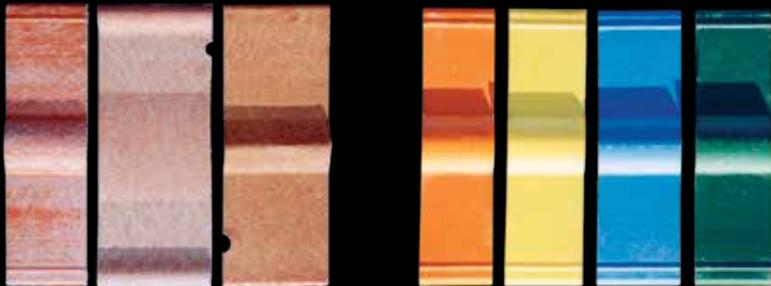
2,000-Hour Weatherometer Testing

Without PolyTech Coating

With PolyTech Coating
