# model 5874PB

Fountain Valve

#### INSTALLATION INSTRUCTIONS FOR 5874PBF.

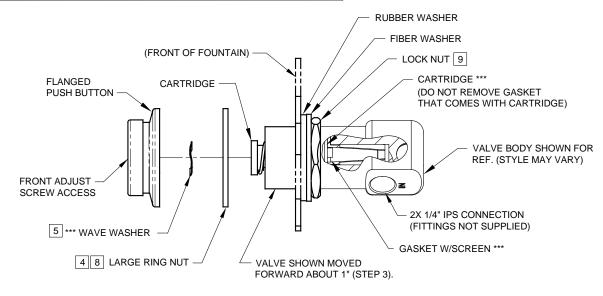
FIGURE 1

\*\*\* MODEL VRK5874 & VRK5874HF- VALVE REPAIR KITS INCLUDE THESE ITEMS

- 6 APPLY ONE (1) DOT OF LOCTITE 222MS, ON THE FEMALE THREADS OF BUTTON ASSEMBLY LEAVING THE FIRST AND LAST THREADS FREE. (FIGURE 1). CAUTION: EXCESS LOCTITE CAN CAUSE THREADS TO LOCK VERY TIGHTLY, MAKING REPAIRS DIFFICULT.

- 9 PUSH VALVE BACK TOWARD THE INSIDE OF BRACKET AND TIGHTEN LOCKNUT (SEE ILLUSTRATION ABOVE).
- 10) TIGHTEN PUSH BUTTON ASSEMBLY USING UNIVERSAL SPANNER WRENCH PROVIDED.

ASSEMBLED 5874PBF

(FLUSH MOUNT APPLICATION)

- 1) FOLLOW INSTRUCTIONS CAREFULLY ON O&M MANUAL (PAGE 2 OF 6) WHEN REMOVING OLD VALVE. NOTE: SEE PARTS BREAKDOWN (PAGE 4 OF 6) FOR ADDITIONAL NOTES.
- 2) VERIFY THAT LOCK NUT, FIBER, AND RUBBER WASHERS ARE POSITIONED SLIGHTLY PAST MIDWAY OF THREADS ON NEW VALVE BODY.

- 3) INSERT VALVE INTO BRACKET FROM INSIDE AND PUSH FORWARD ABOUT 1".
- 4 THREAD LARGE RING NUT ONTO VALVE BODY, APPROXIMATELY 1" INTO VALVE.
- 5 PLACE WAVE WASHER INSIDE OF FLANGED PUSH BUTTON ASSEMBLY (MUST BE IN PLACE).

- \*\*7) THREAD FLANGED PUSH BUTTON ASSEMBLY ON VALVE UNTIL WAVE WASHER MAKES SLIGHT CONTACT WITH STEM OF CARTRIDGE. CAUTION: DO NOT HAND-TIGHTEN.
- 8 UNTHREAD RING NUT FORWARD UNTIL IT STOPS FLUSH WITH PUSH BUTTON ASSEMBLY.

- \*\* OVERTIGHTENING WILL PRE-ACTUATE VALVE AND CAUSE WEEPAGE, WHILE NOT ENOUGH CONTACT BETWEEN WAVE WASHER AND STEM CAN CAUSE A LOW FLOW CONDITION.

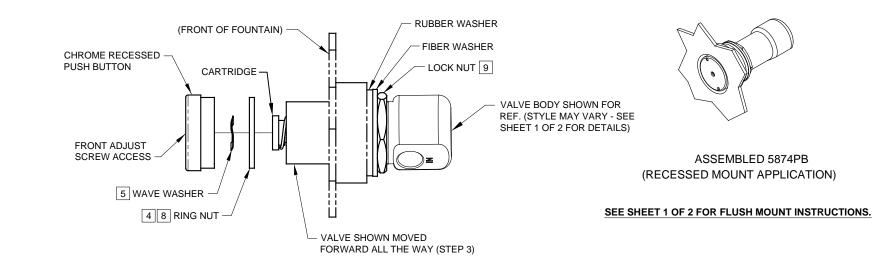
FIGURE 1

- 3) INSERT VALVE INTO BRACKET FROM INSIDE, AND PUSH ALL THE WAY FORWARD (SEE ILLUSTRATION ABOVE).
- 4 THREAD RING NUT ONTO VALVE BODY, AS FAR IN AS POSSIBLE, TOWARD FRONT OF FOUNTAIN. NOTE: IF REPLACING A 5871 OR 5872 SERIES VALVE, YOU MAY HAVE TO CONTACT HAWS TECHNICAL SUPPORT.

- 5 PLACE WAVE WASHER INSIDE OF PUSH BUTTON ASSEMBLY (MUST BE IN PLACE).
- 6 APPLY ONE (1) DOT OF LOCTITE 222MS, ON THE FEMALE THREADS OF BUTTON ASSEMBLY LEAVING THE FIRST AND LAST THREADS FREE. (FIGURE 1). CAUTION: EXCESS LOCTITE CAN CAUSE THREADS TO LOCK VERY TIGHTLY, MAKING REPAIRS DIFFICULT.

- 9 PUSH VALVE BACK TOWARD THE INSIDE OF BRACKET AND TIGHTEN LOCKNUT (SEE ILLUSTRATION ABOVE).
- 10) TIGHTEN PUSH BUTTON ASSEMBLY USING UNIVERSAL SPANNER WRENCH PROVIDED.

- 1) FOLLOW INSTRUCTIONS CAREFULLY ON 0&M MANUAL (PAGE 2 OF 6) WHEN REMOVING OLD VALVE. NOTE: SEE PARTS BREAKDOWN (PAGE 4 OF 6) FOR ADDITIONAL NOTES.
- 2) VERIFY THAT LOCK NUT, FIBER WASHER, AND RUBBER WASHERS ARE POSITIONED TOWARD BOTTOM END OF THREADS ON NEW VALVE BODY.

- \*\*7) THREAD PUSH BUTTON ASSEMBLY ON VALVE UNTIL WAVE WASHER MAKES SLIGHT CONTACT WITH STEM OF CARTRIDGE. CAUTION: DO NOT HAND-TIGHTEN.
- 8 UNTHREAD RING NUT FORWARD UNTIL IT STOPS FLUSH WITH PUSH BUTTON ASSEMBLY.

- \*\* OVERTIGHTENING WILL PRE-ACTUATE VALVE AND CAUSE WEEPAGE, WHILE NOT ENOUGH CONTACT BETWEEN WAVE WASHER AND STEM CAN CAUSE A LOW FLOW CONDITION.
